RESERVE FUND STUDY

*STONEBROOKE CONDOMINIUM ASSOCIATION
CHAGRIN FALLS, OHIO*

MARCH 17, 2020

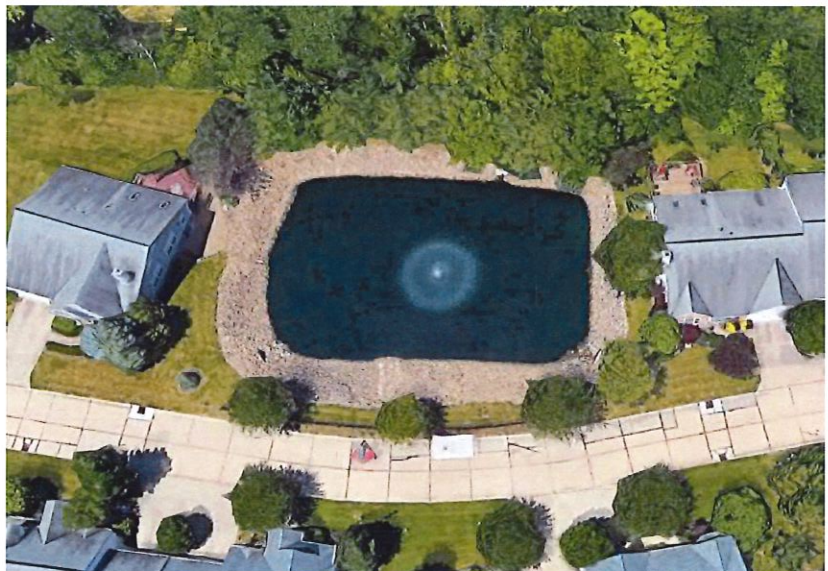
Pond on West Side of Stonebrooke Oval

The two ponds and fountains appear to be in good condition and well maintained. The shore line has rip rap rock piles to protect from shore erosion and we did not observe shallow areas that would indicate build up of silt and dirt from storm water run-off. The day of our inspection we did not see the fountains in operation, however we have included the fountains as shown in the following historical satellite views from Google Earth.

1. Future fountain repairs and replacements. There is a total of 2 fountains that are included.
2. Shore erosion control by means of refreshing the rip rap shore along shore lines every 12 years.
3. Dredging of both ponds once every 30 years to ensure the ponds remain deep enough for proper storm water drainage control.

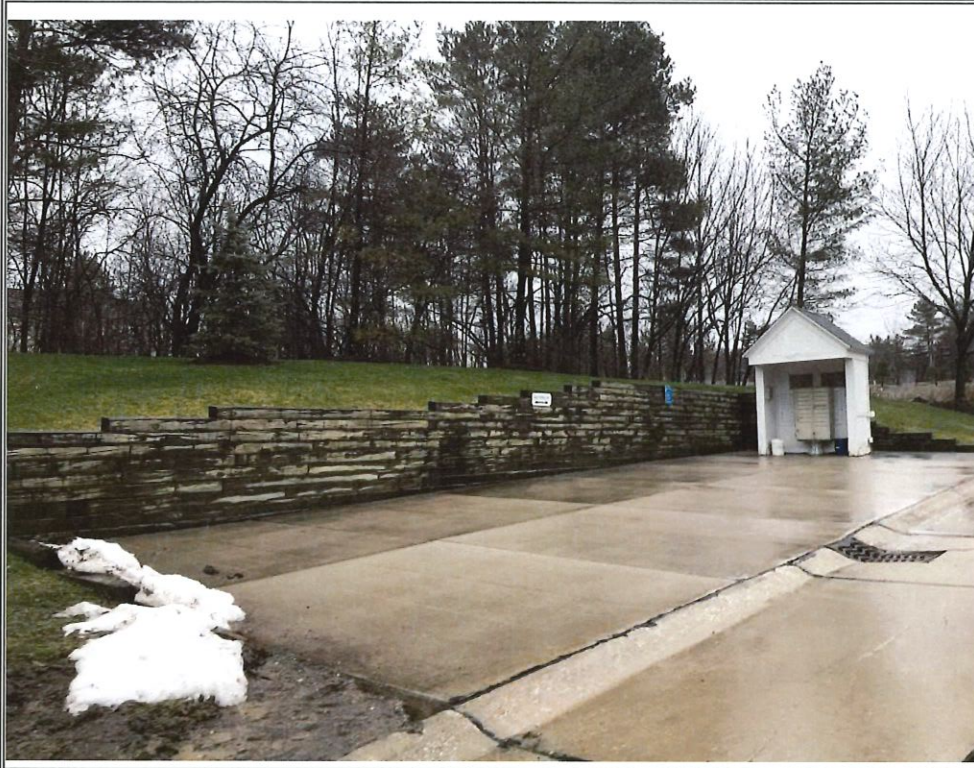
Photo Number
5

- **Mailbox Shelters and Kiosks** – There are 3 mailbox stations that have parking, shelters and kiosks. The mailbox shelters are in good condition and are made with wood and roofs that protect the kiosks. We have included an allowance of \$2,500 for each of the 3 mailbox shelters to be repaired or replaced every 25 years. We also include a separate allowance to replace the mailbox kiosks once every 25 years.

One of three
mailbox stations

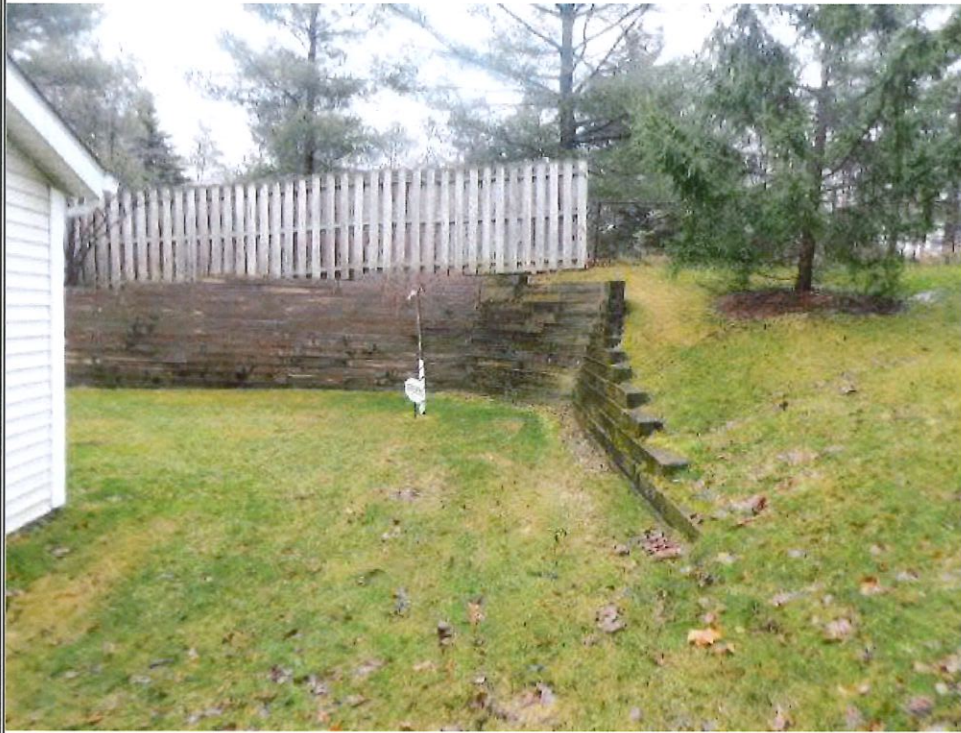
Photo Number

- **Timbers for retaining walls** – We observed that there are wood timber retaining walls at some of the properties between buildings and along steep hills and they are in good condition. We have included phased replacement of portions of timber walls once every 15 years.

Large retaining wall

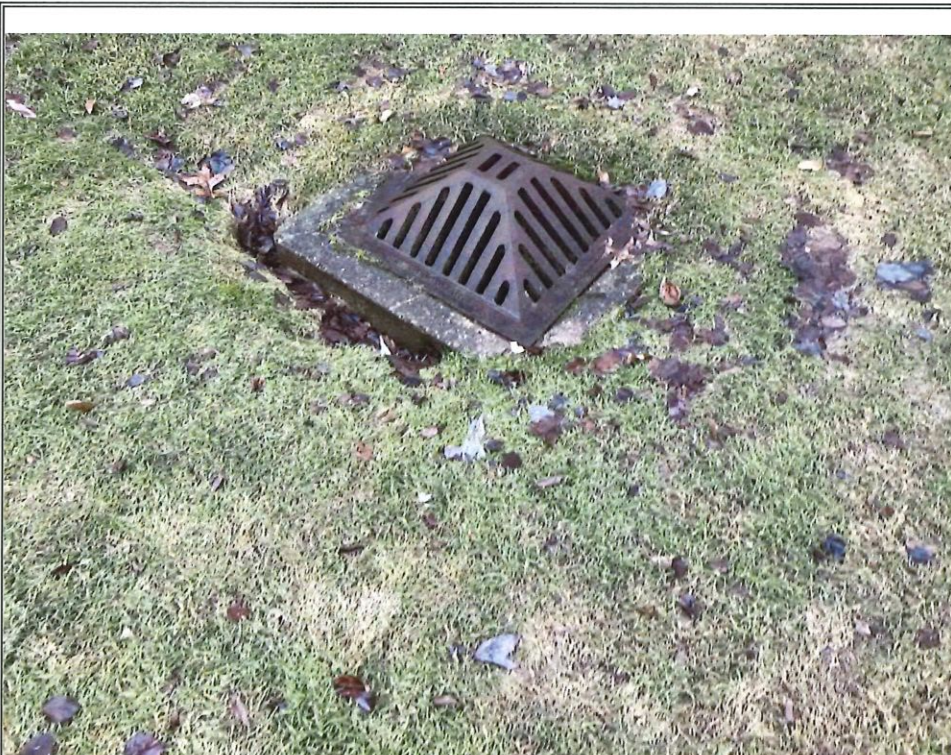
Catch basin with
erosion

- **Catch basins and site drainage** – Based on our observations we estimate that there are 38 catch basins throughout the property, some along street curbs and others in grass areas, that are part of storm water management. We have included an allowance for repairs to basins and basin grates.
